## Contents

## Tubbs-Reed House, ca. 1800

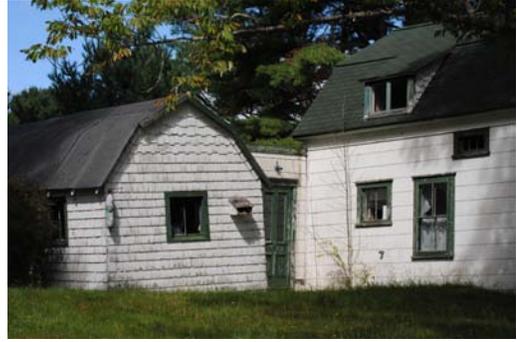
**View:** South elevation.

**Notes:** Gambrel roof side ell (at left) falling off foundation. Roofing inadequate.

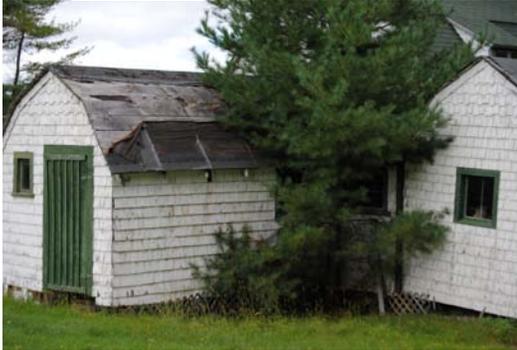
**View:** Southwest corner of ell and sheds.

**Notes:** Ell at right falling off foundation. Roofing inadequate on shed (at left)

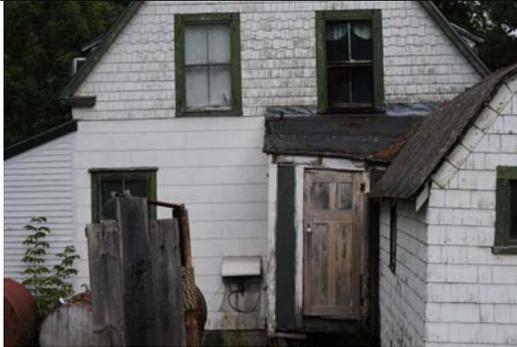
**View:** Western elevation of main house, connector and shed.

**Notes:** Foundation under door fully compromised, as is the roofing. **This section of the building is in poor condition.**

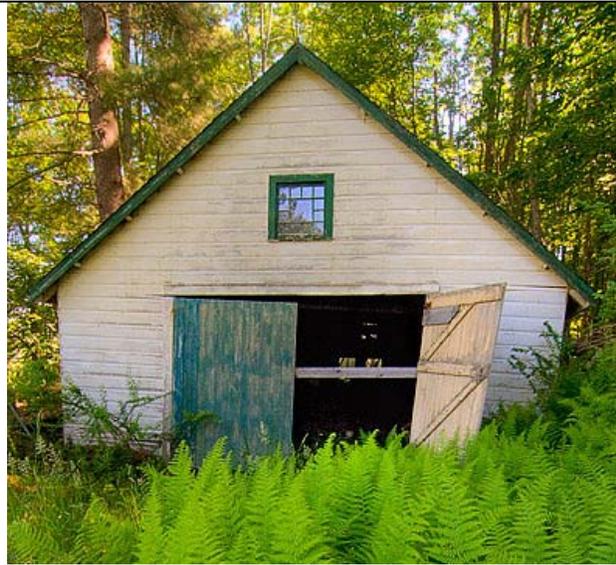
**Condition:** Very Poor. Building is collapsing.  
Roof is severely deteriorated.

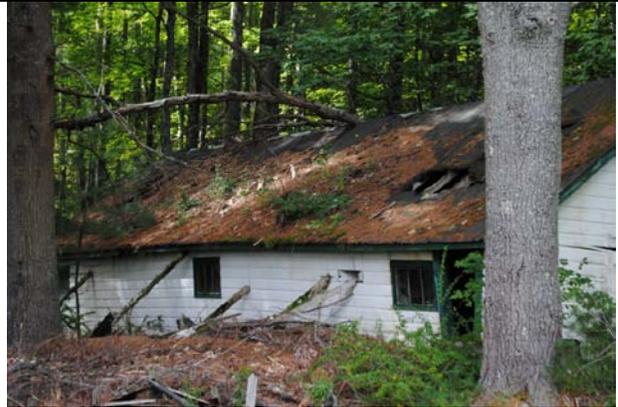
**View:** Southeast elevation.

**Notes:** Building is near collapse.

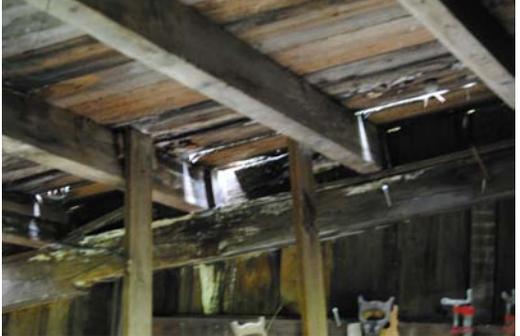
<p><b>View:</b> Interior roof of machine shed.</p> <p><b>Notes:</b> Images shows mold and rotting roof boards.</p>

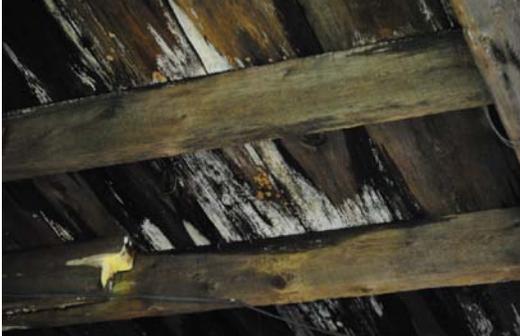
**View:** Machine Shop Interior

**Notes:** Workspace area. Poor condition.

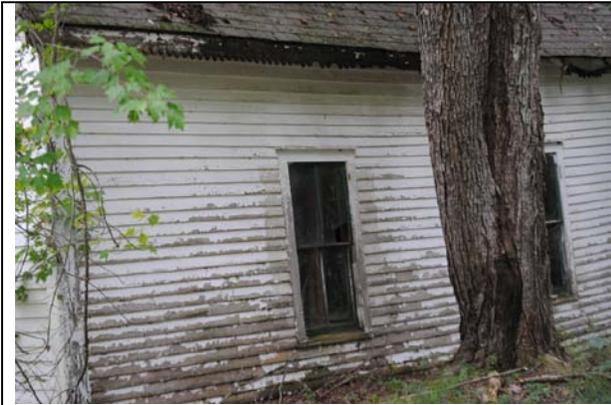
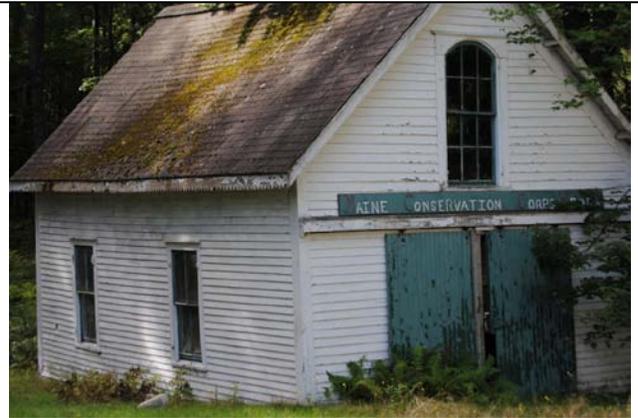
**Condition:** Fair to poor. Sills appear compromised. Roof in poor condition.

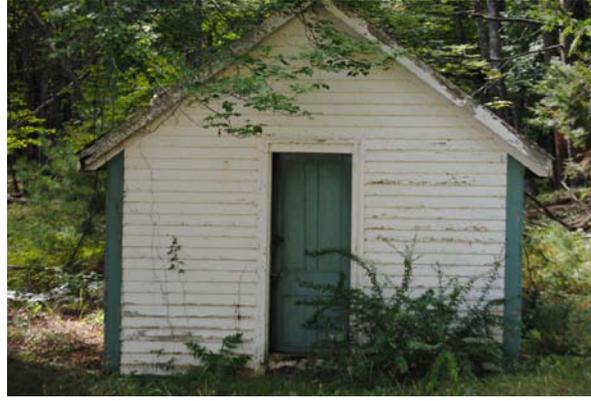
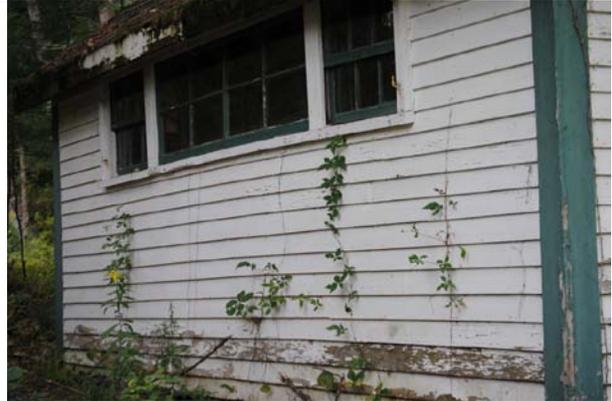
**Robinson-Powell House, Shed**

**Condition:** Fair to poor. Sills appear compromised. Roof in poor condition.

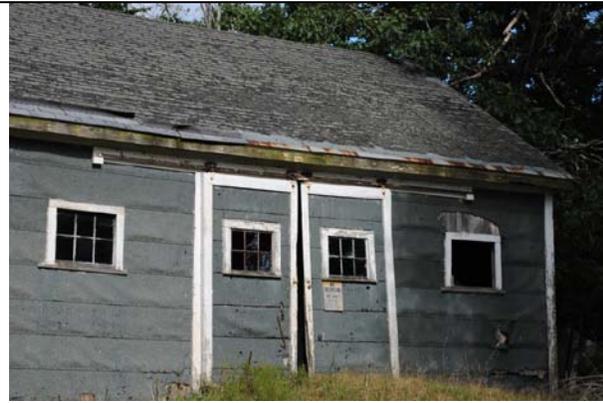
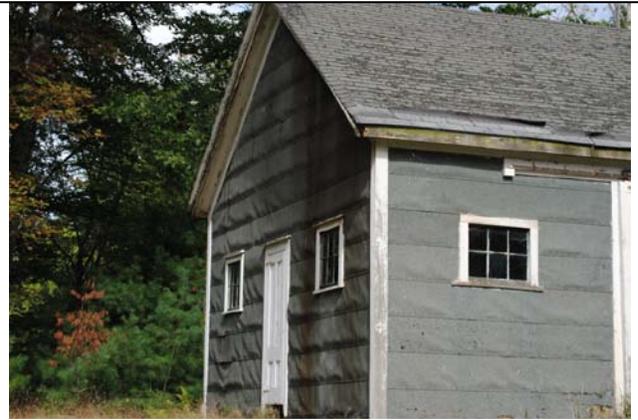
**Condition:** Poor. Roof leaks heavily, building has shifted and settled. Occupied by bats and porcupines.

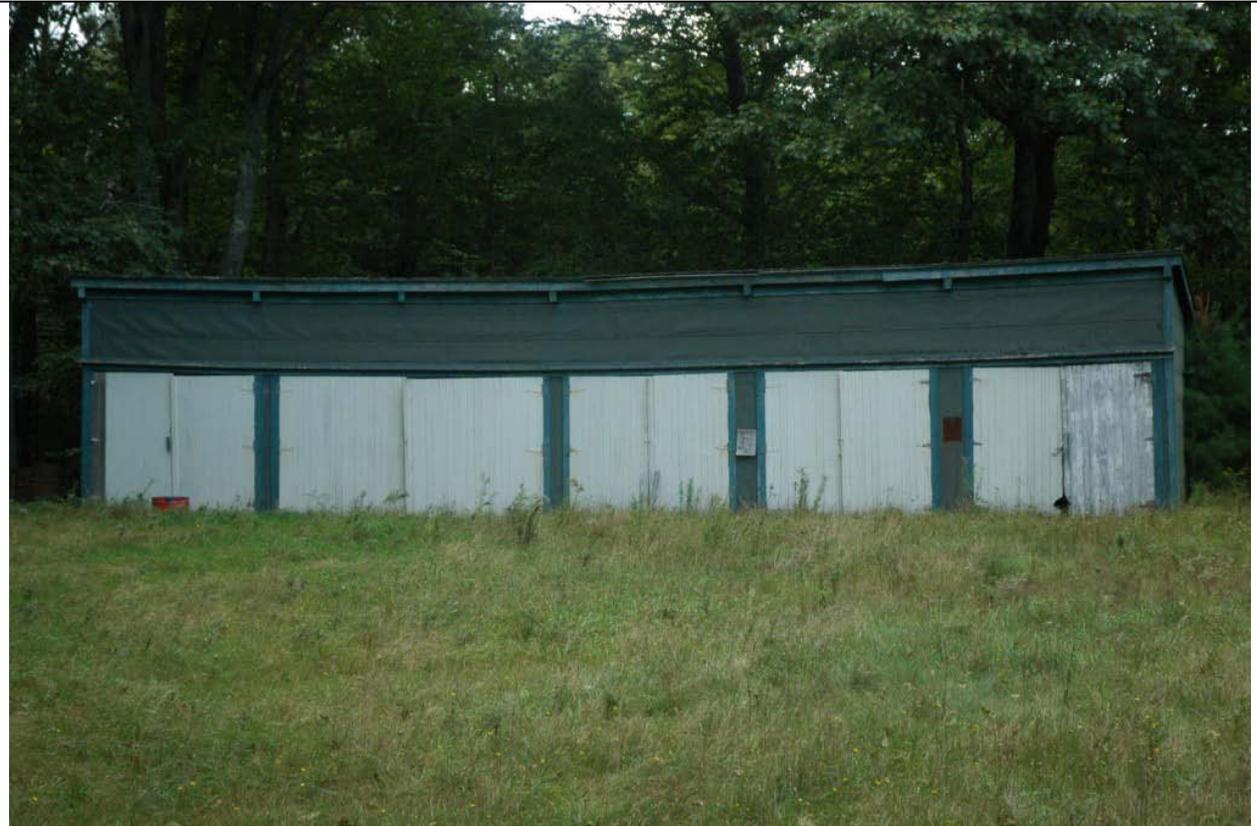
**Lilly Wade House, Equipment/Carriage Shed.**

**Condition:** Poor. Building is settling, roof is deteriorated.
