A Master Plan For Swan Island

Prepared for:
The State of Maine
Bureau of General Services
And
The Department of Inland Fisheries and Wildlife

Prepared by:
Mohr & Seredin, Landscape Architects, Inc.
18 Pleasant Street
Portland, Maine

Winter, 1999 – 2000

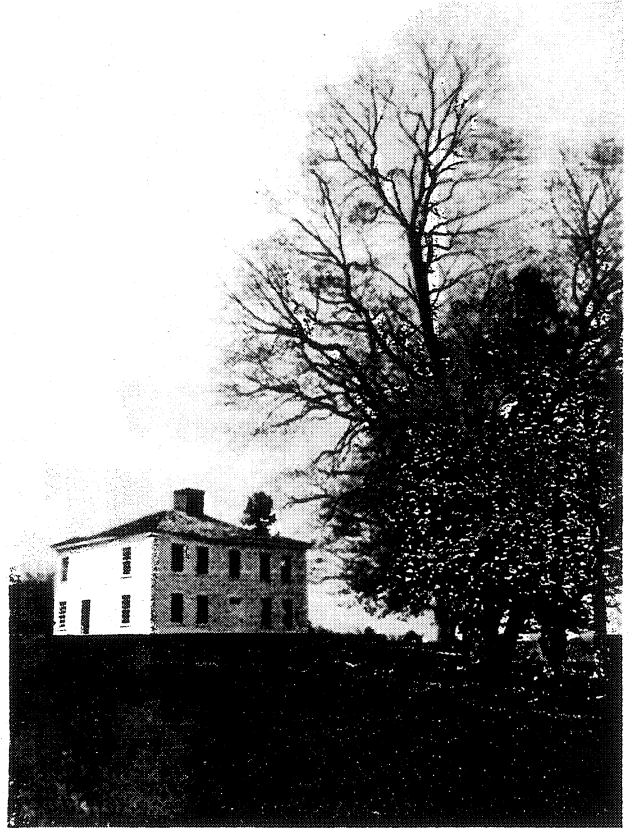
The Tubbs-Reed House
Photo: Lloyd Ferris

Tubbs-Reed House: This is the house closest to the island boat landing. It is in fair condition and has been undergoing stabilization measures. There are no utilities and it is not currently used.

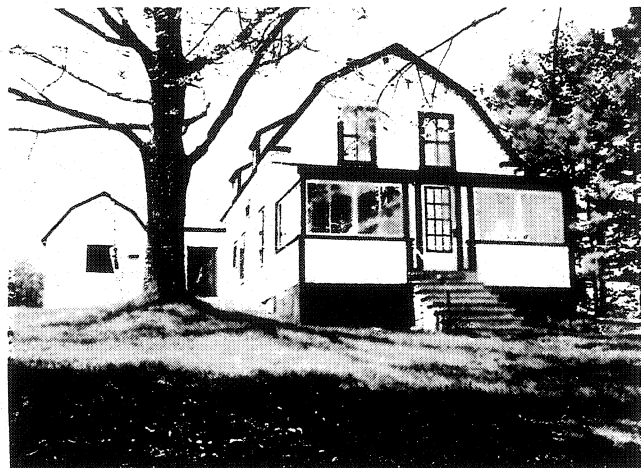
The Priest House
Photo: Lloyd Ferris

Priest House: IF&W administrative offices and staff residence are located in the Priest House. It is in fairly good condition, and has telephone, water, heat, and electric services.

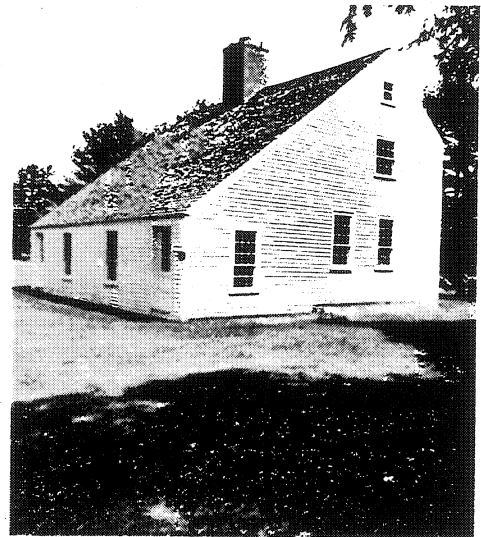
*Gardiner-Dumaresq House
Photo: Lloyd Ferris*

Gardiner-Dumaresq House: This is a saltbox design with previous as well as ongoing stabilization measures. There are no utilities and the house is in fair condition.

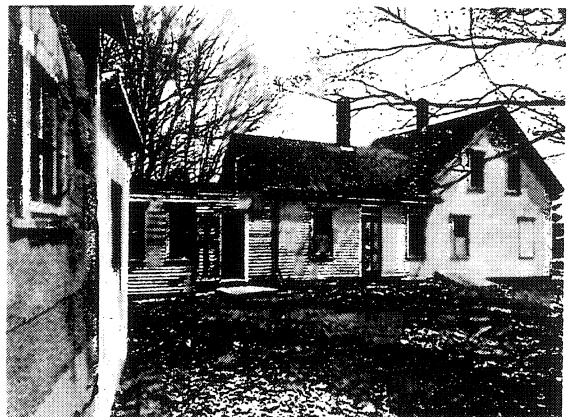
*Lilly-Wade House
Photo: Lloyd Ferris*

Lilly-Wade House: There are barns associated with the house which is in fair to poor condition and it is currently undergoing emergency stabilization measures. There is no utility service.

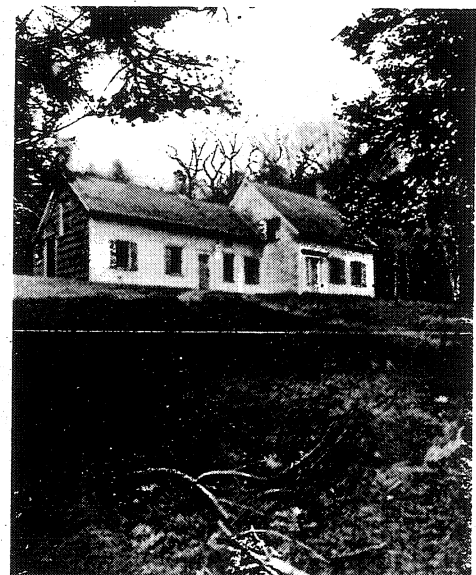
*Maxwell-Tarr House
Photo: Lloyd Ferris*

Maxwell-Tarr House: This building has no current use, and is in poor condition with no utility service. As this master plan is being completed, plans are being made to remove the house due to its poor condition.

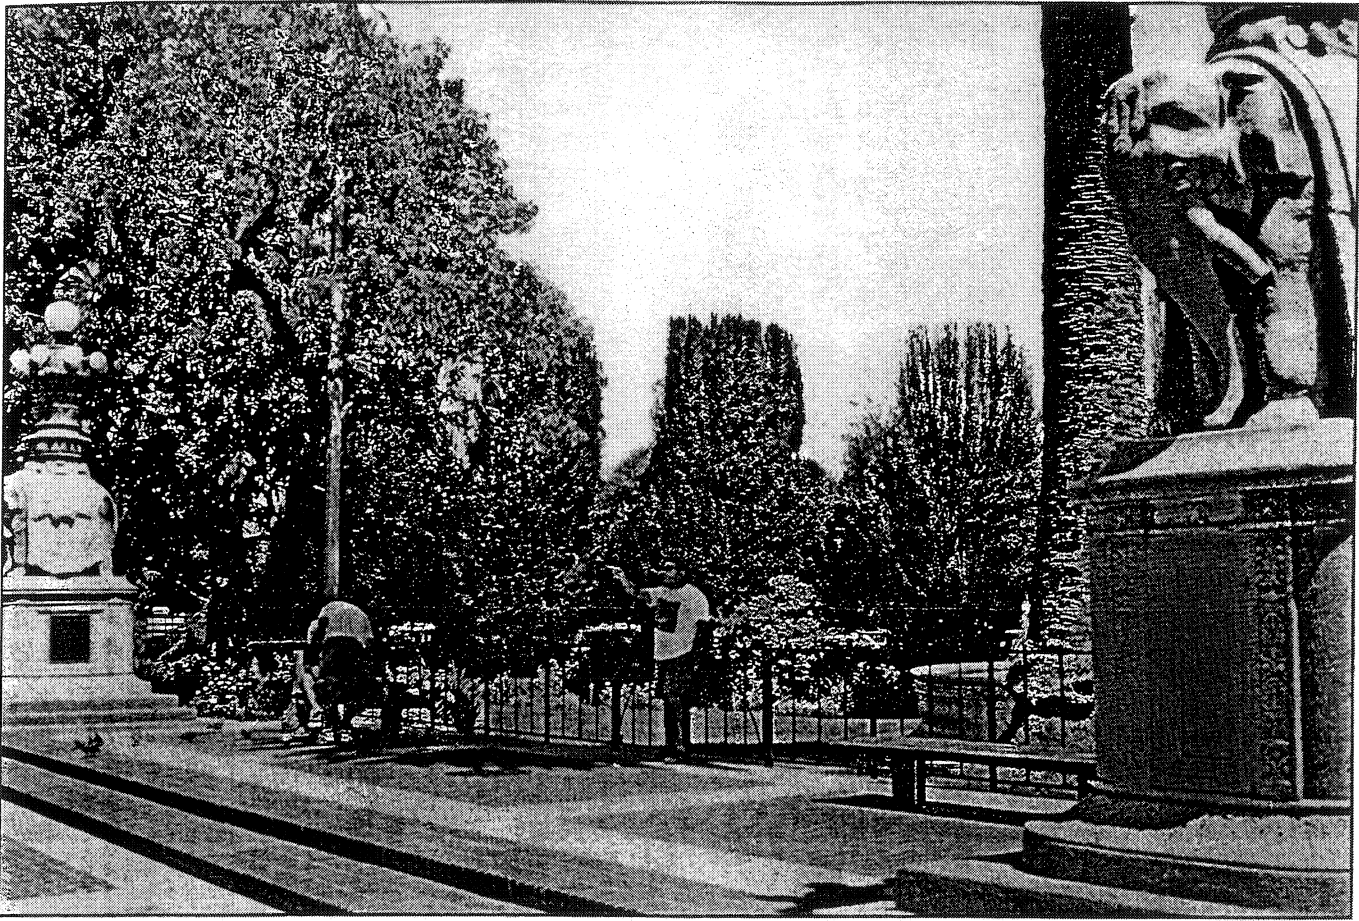
These unique historic lightposts at a small park in Sausalito, California, have been preserved. An integral part of the project work included a code-required upgrade and improvement of the fixtures for energy efficiency. (author, 1993)

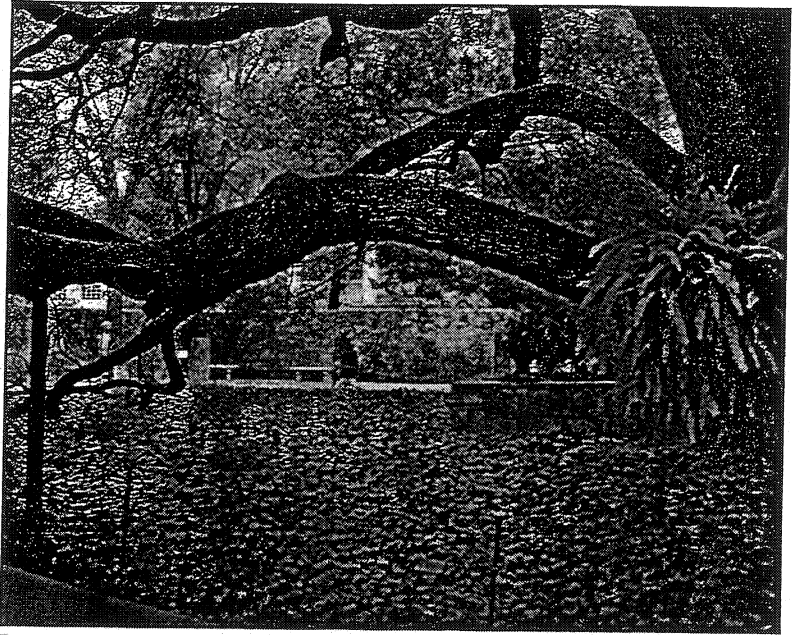
To preserve a century-old oak, a stabilization rod [see left side of photo] was applied to a limb that overhangs a pedestrian walk at the Alamo, San Antonio, Texas. (author, 1993)

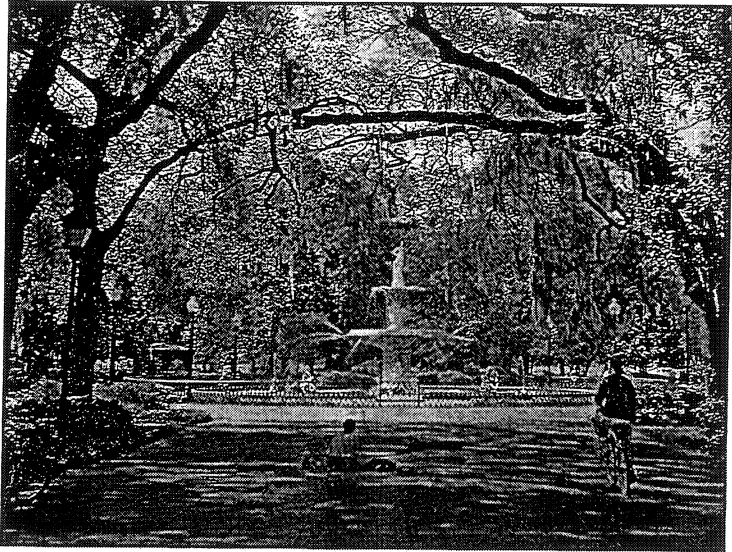
This character-defining avenue of oaks in Forsyth Park, Savannah, Georgia, have been pruned to lighten their canopy, thus providing protection from severe storms. (author, 1996)

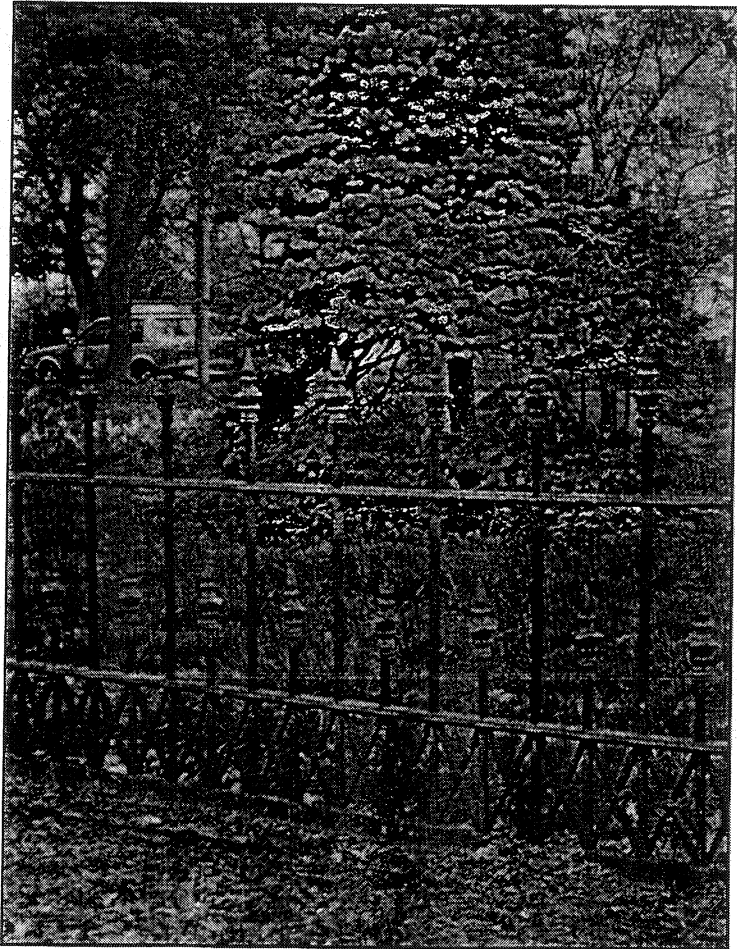
Castings were made to replace a limited number of lost finials along the perimeter fence of Lafayette Square, St. Louis, Missouri. (author, 1994)

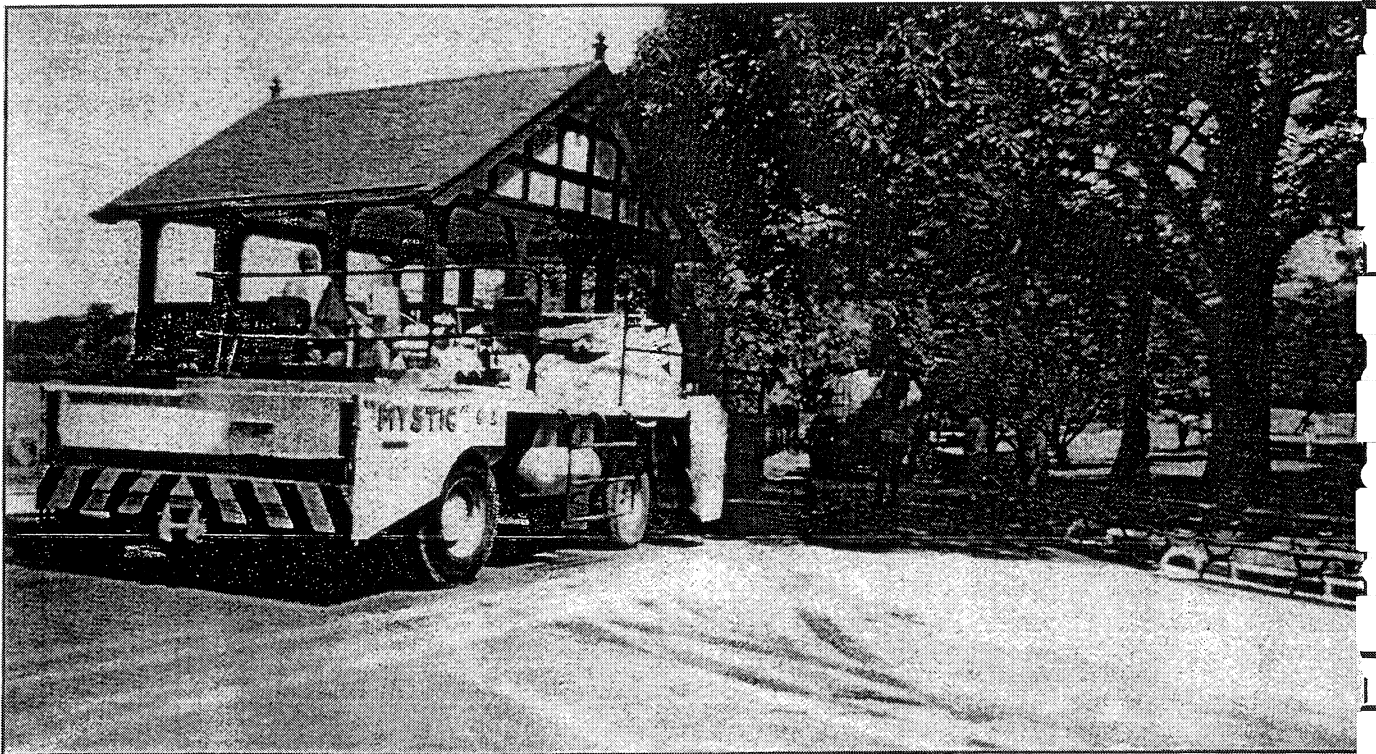
As part of a preservation project, the walks around Boston's Jamaica Pond Park were repaired and resurfaced. A loose, crushed stone surface material (an embedded aggregate) was rolled into the asphalt surface, thus allowing for upgraded uses such as jogging, biking and snow removal, while retaining the historic character. (FLONHS and author, 1990)

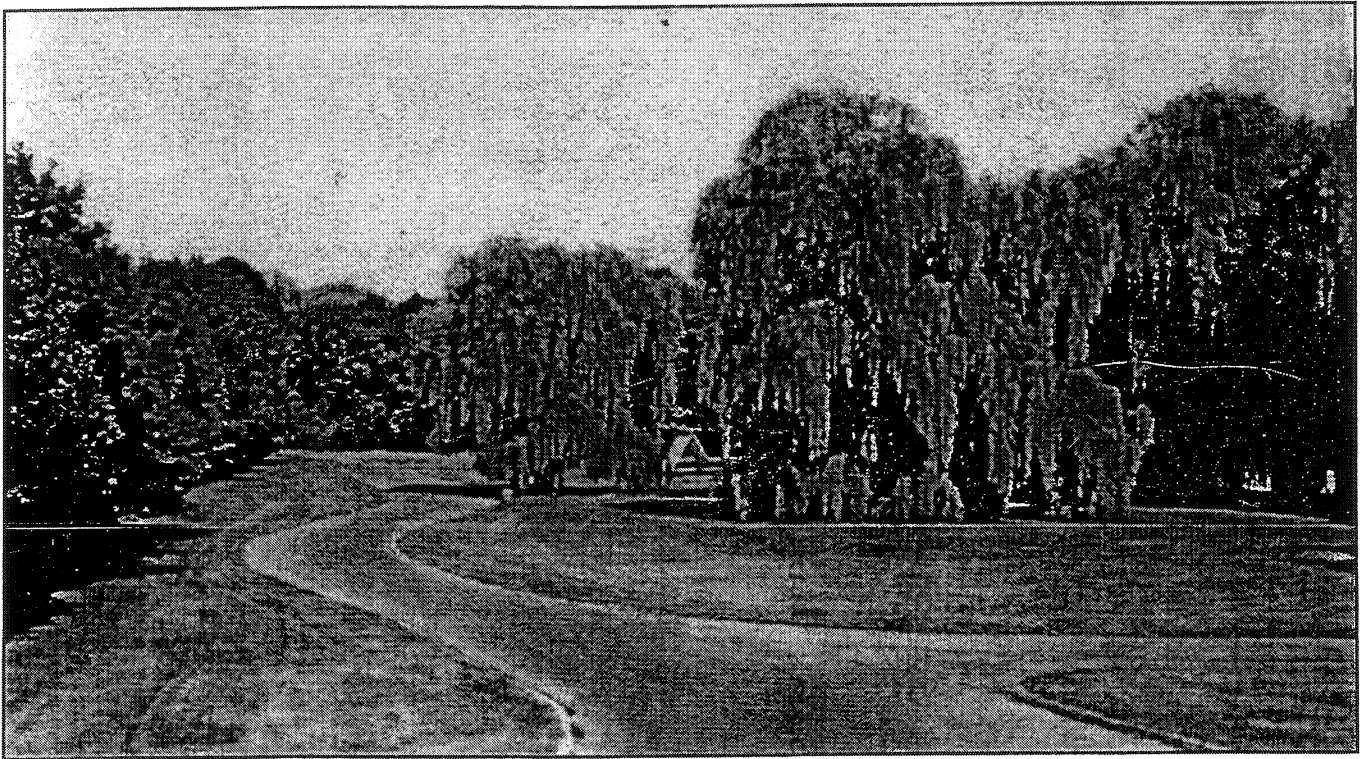
In the 1980s, Star Lake in Lower Onondaga Park in Syracuse, New York, was filled-in without undertaking any research or analysis. This loss of this character-defining feature significantly altered the park's spatial relationships. (Onondaga County Historical Society and author, 1989)

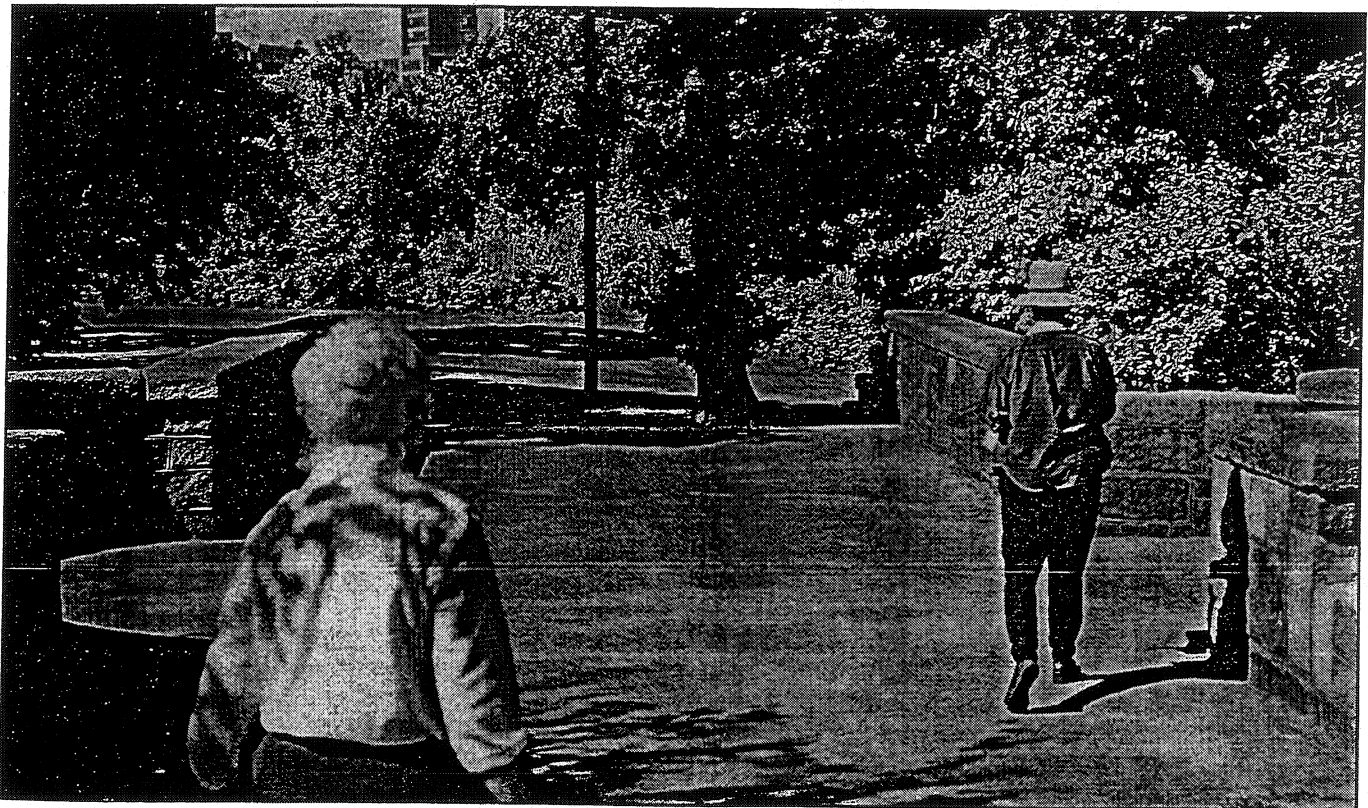
Many of the stones from the Island Bridge along Boston's Riverway had fallen into the Muddy River below. As part of the preservation work, these stones were retrieved from the water and reused, in addition to several new stones that were cut to order to replace in-kind those that were lost. (author, 1988, 1994)

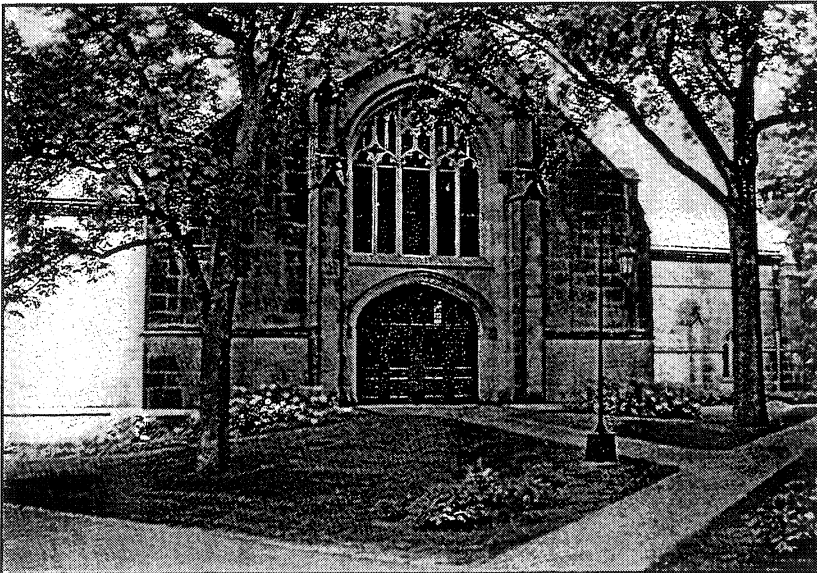
To meet ADA requirements, accessibility to the Houghton Chapel at Wellesley College has been provided from a secondary entrance. The landscape in this area possessed little integrity--thus, as part of this regrading operation, the historic granite stairs were buried below and preserved in-situ, below the new grade. (Carol R. Johnson Associates, Inc.)

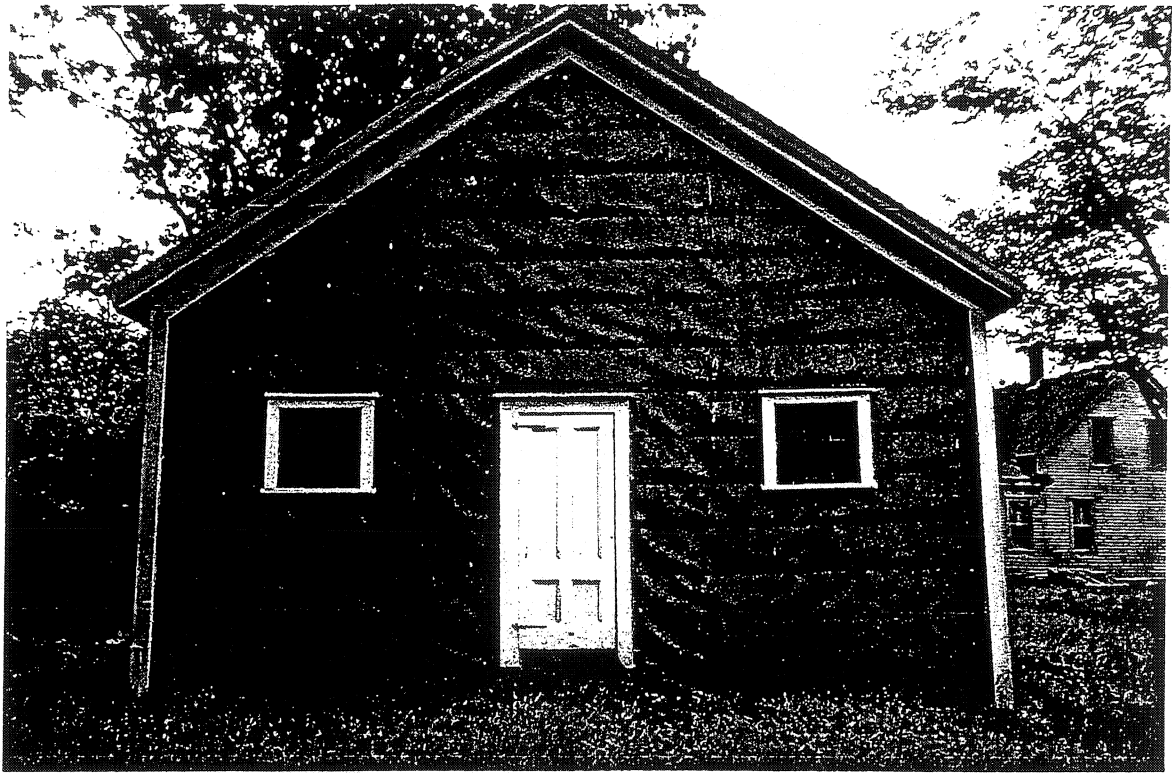
Toilet facility has similar proportions to this existing historic outbuilding.

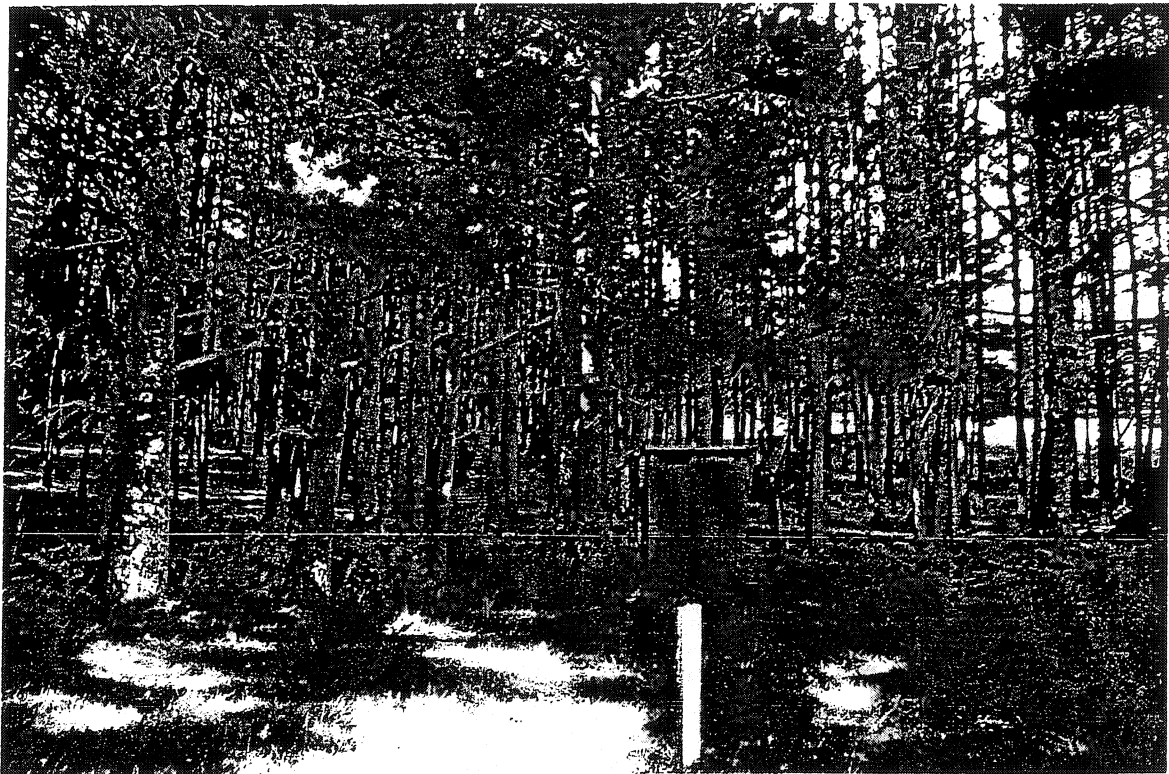
Abandoned outhouse

This is a preliminary solution to provide a facility that is to replace the "job johnnies" and the abandoned open-pit outhouse. It will also provide water.

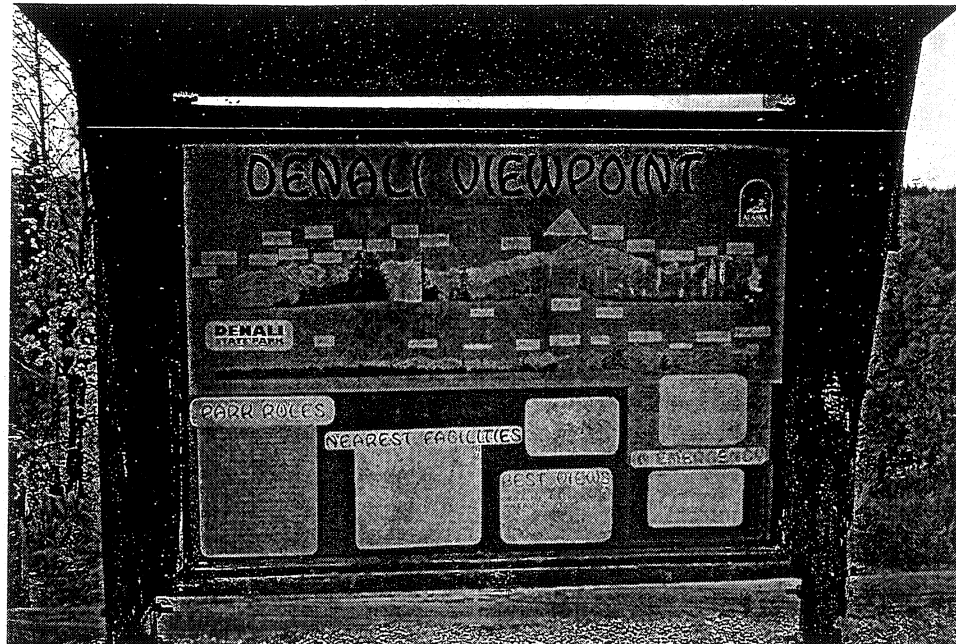
The shelter invites you to leave your car and study the information provided. It also protects the materials from the elements.

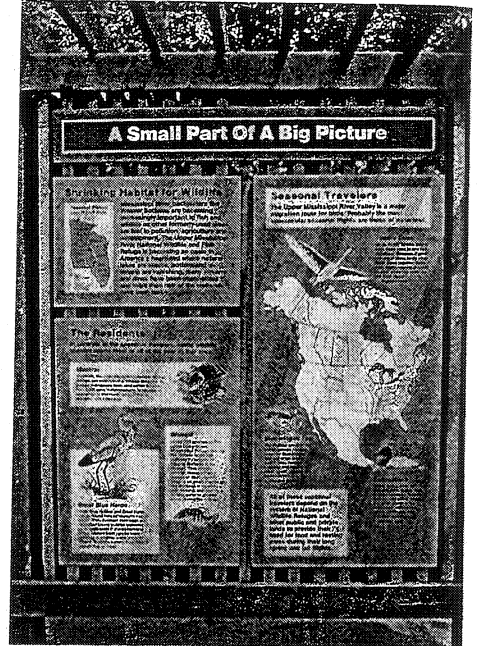
Upper Mississippi River National Wildlife and Fish Refuge

spring flooding. Panels are mounted individually which allows for easy removal for painting or repairing. They are mounted with "theft-proof" vandal-resistant screws. This com-

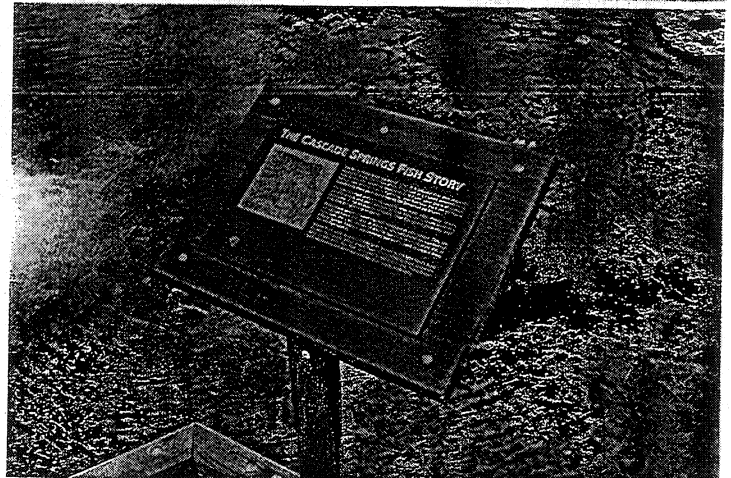
This trail uses metal and fiberglass signs mounted on wood supports and wood panel backing. The unity of design, from entrance sign to trail panels, shows sensitivity to the landscape.
