NEWPORT STREAM RESTORATION
ARCHAEOLOGICAL SURVEY
AND SITE 71.30

Arthur Spiess
February, 2003
Maine Historic Preservation Commission

PROJECT BACKGROUND

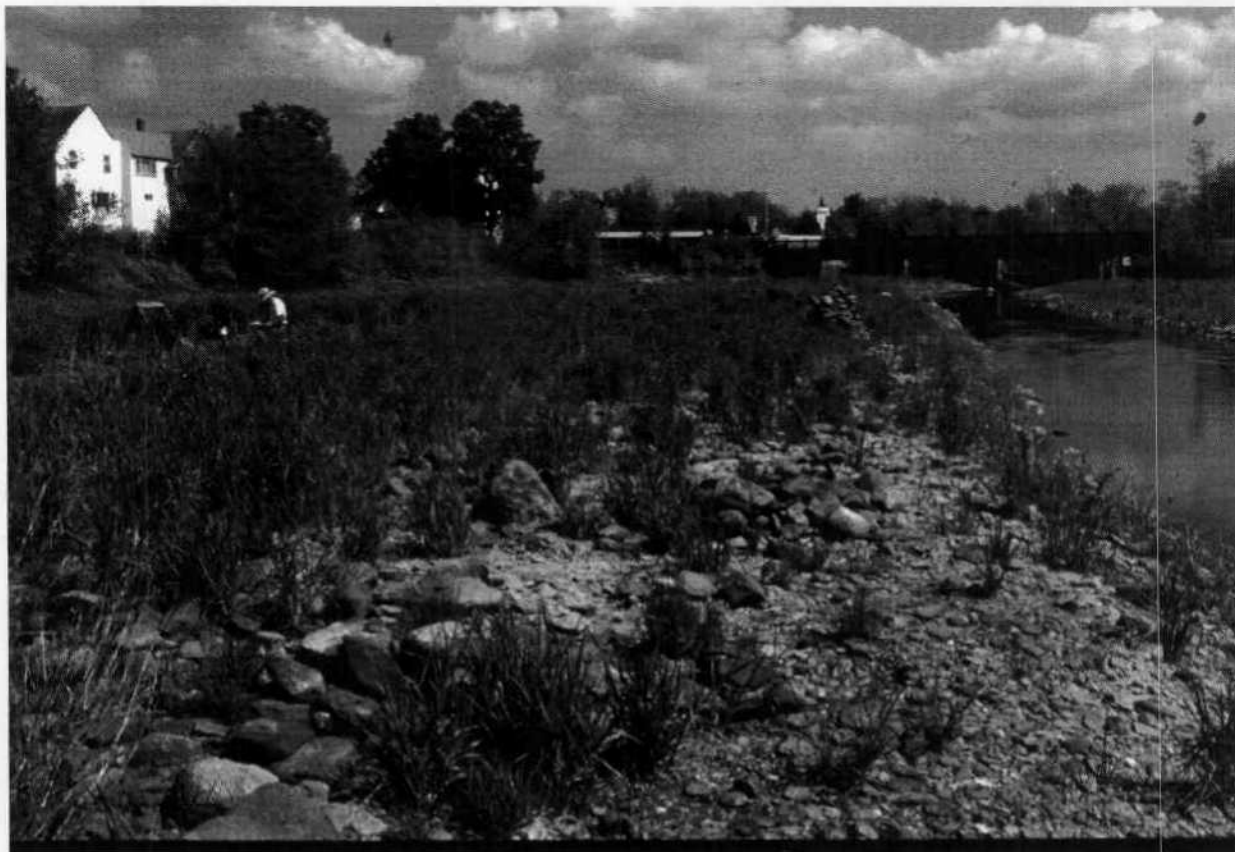
Figure 4. Looking south across site 71.30 toward the Route 2 bridge. Artificial river channel to the right. Stone cairn (see map, Figure 5) along river bank in right center of photograph.

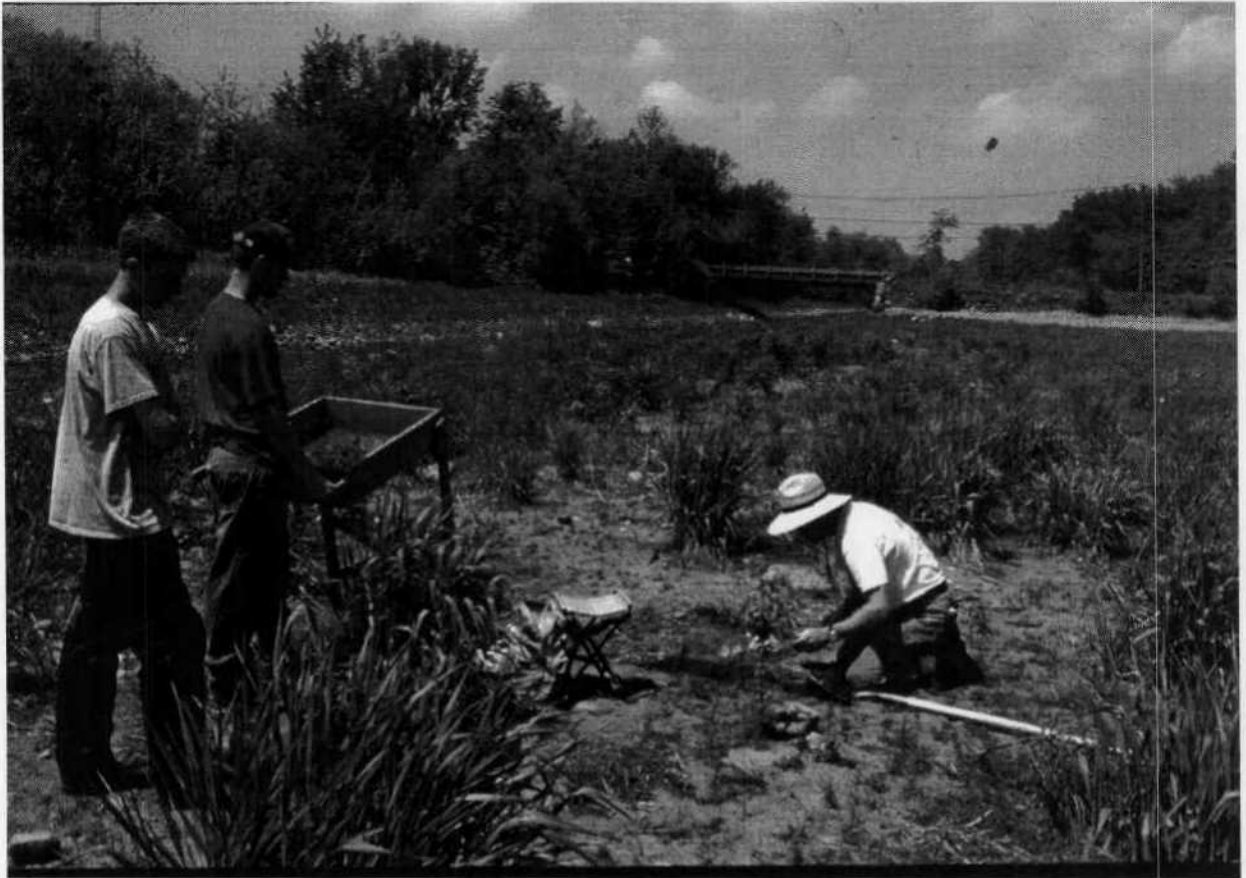
Figure 6. Starting excavation of Testpit 1, looking north. K. Mathiasson in straw hat. Volunteers Buzanoski and Mullis at left.

TP 1. Sandy surface, no vegetation, with a scatter of FCR and rhyolite on the surface. This testpit was located on the highest portion of the surface between the old river channel and new channel. Excavated by Kåre Mathiasson, it produced a great deal of debitage, a couple of points, a piece of ceramic (possibly CP3 age) and a feature remnant (compressed A and B soils) with charcoal and calcined bone. This is a 1 x 1 m square. Testpit 1 was excavated in 50 x 50 cm quadrangles (quarters) and 5 cm levels. The upper 5 cm (0-5 cm) level was redeposited medium-brown sandy material, containing artifacts. Alternatively, this material could have been deflated in situ, losing its silt and clay particle content, leaving the sandy material behind. At very close to 5 cm depth (± 0.5 cm) the soil changed to a more compacted silty sand that was dark brown to black in color. We identified this dark, compacted soil at 5 - 10 cm depth as a remnant or compacted A soil horizon. The 5 cm surface was troweled carefully, and a probable hearth (FCR, darker soil, calcined bone concentration), designated Feature 1, was identified in the southeast quadrant. At 10 cm depth,

Feature 1 was a dark red stain in the southeast quadrant, apparently oxidized subsoil. At 10 to 20 cm depth in the other quadrants, the soil was an olive brown silt. No artifacts were recovered from the 10 to 20 cm olive brown silt subsoil.

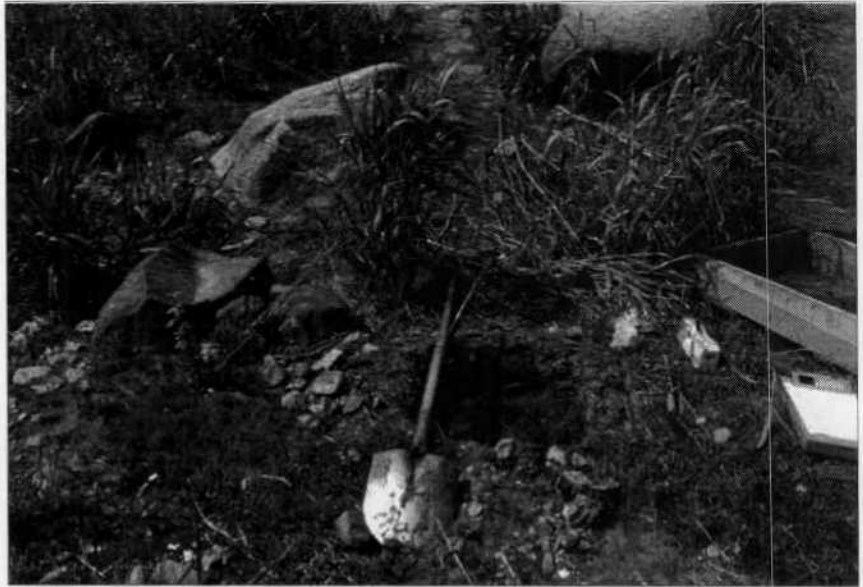
Figure 7. Testpit 2 excavation underway, looking north. Note the cobble and gravel surface lag deposits, which include fire cracked rock.

TP2. Located among boulders about 10 m from waters edge. Intense FCR and coarse sand on the surface. 50 x 50 cm testpit. Among grass clumps. FCR and a few flakes in 0-15 cm sandy recent flood deposit, over a 2 cm thick (15-17 cm b s) discontinuous dark brown compressed former forest A horizon. Over tan to light brown silty clay C horizon that appears to be sterile. This stratigraphy is compress and/or deflated, as Kaare noted in testpit 1. Spiess excavated. (All soil screened through 1/4" mesh.) A sample of FCR saved. Excavation stopped at 25 cm.

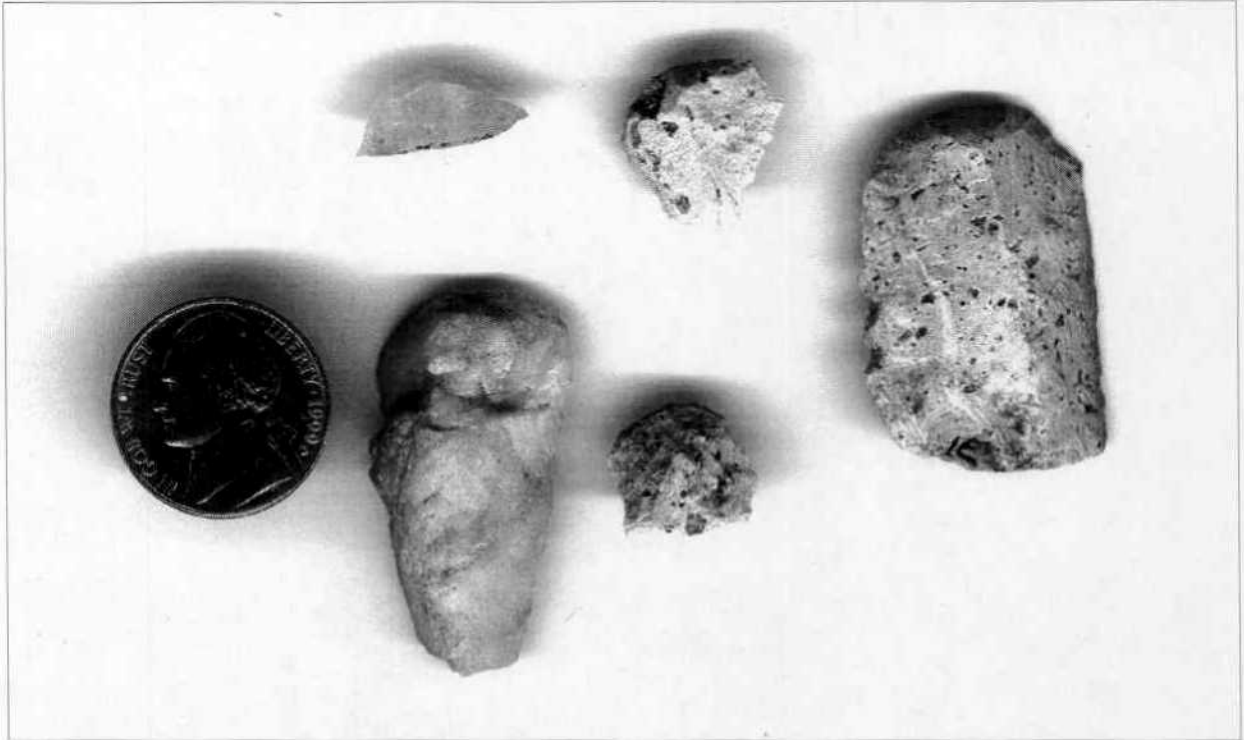
Figure 8. Endscrapers, all from Testpit 1. Upper left #73, upper center #53, right #31, lower left #54, lower center #61. Nickel for scale.

The most common stone tools are "thumbnail" endscrapers (Figure 8). Two, one of quartz and one of Kineo felsite, are large and complete, evidently hafted. Two are quite small and made by retouching small Kineo flakes. One quartz specimen (#73) is a broken working edge fragment from a near-crystalline quartz scraper. Dimensions are presented in Table 4 (top of next page). We note that the working edges on both quartz endscrapers are of acute angle, and neither of these specimens resembles the "high-backed" quartz endscraper characteristic of the Archaic. In fact, all these endscrapers fit within the range of specimens we have seen from Ceramic period sites.

Cat #	Length	Width	Weight	Material	Notes, wear
73	broken	>17.3	0.6	quartz	slight crushing, low angle edge
54	37.5	20.1	7	quartz	slight crushing, low angle edge
31	35.5	23.1	8	Kineo rhy	step flaking, 60-70° edge
53	16.5	16.7	0.9	Kineo rhy	few flakes, 60-70° edge
61	13.4	13.9	0.9	Kineo rhy	undercut step flaking, steep edge

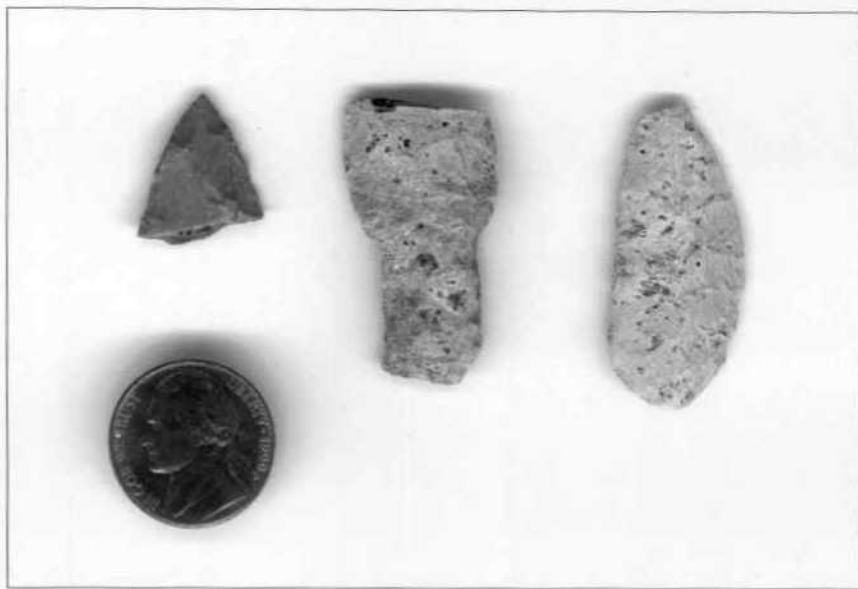
Figure 9. Three points from site 71.30. #72 at right, #44 point tip at left. Point #38 from Testpit 2, center.

The stemmed point (Figure 9 center, below) is made of Kineo rhyolite or a related rhyolite. (The rhyolite exhibits slight flow-banding, but we have seen similar patterns in rhyolites around Moosehead and Brassua Lakes, which is also the origin of Kineo rhyolite.) The point has been broken and the distal portion lost. The proximal portion of the point consists of a long (17 mm) stem with straight sides (13 mm wide), with a finished (retouched to an edge) base. This style of point dates to the early Ceramic period along the coast of Maine (perhaps 2800 to 2200 years ago).

Three bifaces (points) were recovered from Testpit 1 (Figures 9 and 10, next page). #44 is a distal tip of a sharp point made on a fine grained volcanic or chert. The material includes silica-filled cracks and has a purple-tan color. At the break it is thin (5 mm) for its width (16.3 mm). Along with the fine, sharp edges we assume this indicates that the point is Ceramic period in age. (Archaic points tend to be thicker.) (Figure) We can not identify the material, so can not comment on its provenance.

#72 is a asymmetric leaf-shaped biface, bifacially flaked from a small flake of Kineo rhyolite. The tip is missing. This piece is thin for its width (4.5 mm/16.8 mm). The basal 13 mm have a slightly different treatment than the rest of the point: lightly ground on one side and a remnant flake striking platform forming the other side. Our impression is that this is a miniature version of a Ceramic period hafted biface knife (see Spiess and Hedden 1983:71). Again, the identification is not certain.

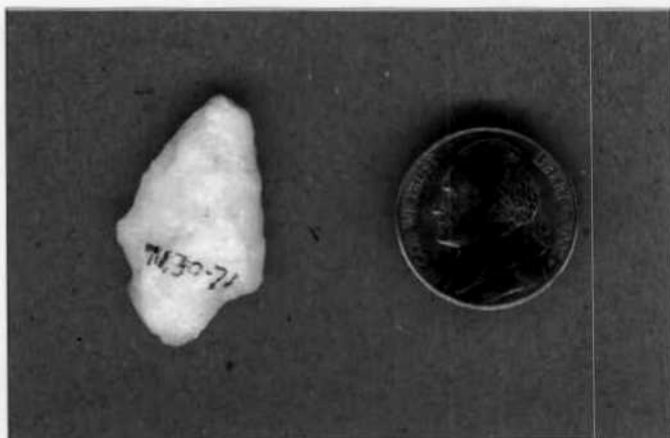
Figure 10. White quartz point #71.

#71 is a contracting stemmed point, made of white quartz (Figure 10). Pieces of quartz such as this must have been the goal of all the quartz cobble breakage. The edges of this point are regularly flakes, and it is relatively thin (6.3 mm) for its width (18.0) at the shoulders. The stem retains a small (1 mm square) area of striking platform, but that small area is off center, and the rest of the stem has been partially trimmed bifacially. In outline this point could be a Late Archaic small-stemmed point or a poorly-made Ceramic period point. Small-stemmed points tend to have the base of the stem occupied by a larger striking platform remnant. (A similar issue of identification occurred on the Anne Hilton site, with similar points [Will and Cole-Will 1989]. We lean toward a Ceramic period identification based on the relative thinness of the point (1:3 ratio).

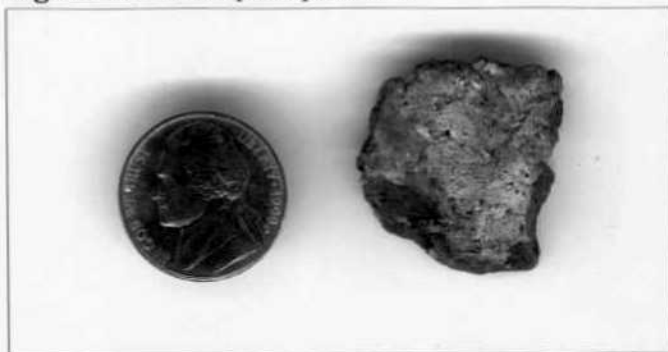
Figure 11. Ceramic fragment (#70) from Testpit 1.

#70 is a relatively large ceramic pot sherd (Figure 11), measuring about 2.5 cm square, and 8.3 mm thick. The temper in the clay is crushed quartz (up to 1.5 mm) and sand particles. Neither the interior nor the exterior surface is decorated. Ceramics exhibiting these attributes could originate in Ceramic Periods 3, 4, or 5 (Petersen and Sanger 1991), roughly 1650 to 650 years ago (or 300 to 1300 A.D.) This piece may be from a lower portion of the vessel, and the vessel could have been decorated with dentate-stamp or cord-wrapped stick impressed decoration around the rim and upper body.

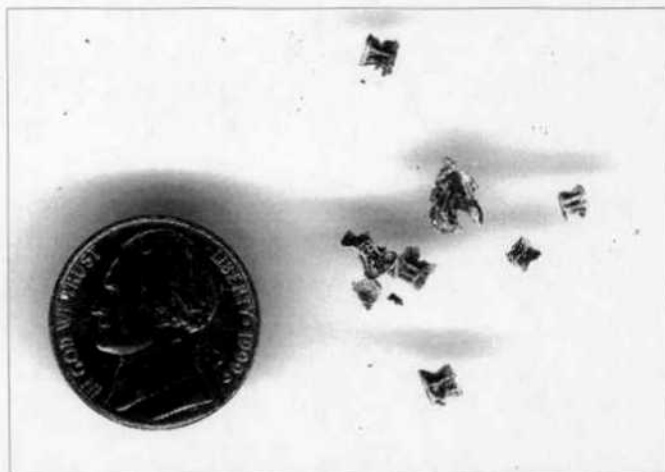
Figure 12. A sample of fish vertebrae from the Feature 1 fill sample. Mostly alewife.

The fish bone was identified by comparison with specimens in the Historic Preservation Commission lab (MHPC collection, or John Mosher collection). One vertebra matched a white sucker. Five bones matched striped bass (two dorsal spine bases, a vomer [skull bone], two vertebra fragments), and clearly were differentiable from white perch (a related fish). The dorsal spine bases are approximately 2/3 the linear width of the comparative specimen at MHPC, which weighted 1.73 kg in the flesh. We estimate that the striped bass represented by these bones weighted approximately 0.8 kg. A total of 194 other fish vertebrae were identified in the Feature 1 sample, and 20 of these are alewife. The alewife vertebrae are 3.5 mm in diameter, matching modern alewife runs in Maine in body size. The other 174 are eel. Eel vertebrae are 1.8 mm in diameter. Much of the small, unidentifiable fish bone, too, appears to be eel-sized fish fragments.
